10th Part of AAEE/853/2

**AEROPLANE AND ARMAMENT
EXPERIMENTAL ESTABLISHMENT**

WYVERN S. MK. 4 VW. 884
(PYTHON 3)

QUALITATIVE LONGITUDINAL AND LATERAL HANDLING TRIALS UP TO
20,000 ft. INCLUDING STALLS

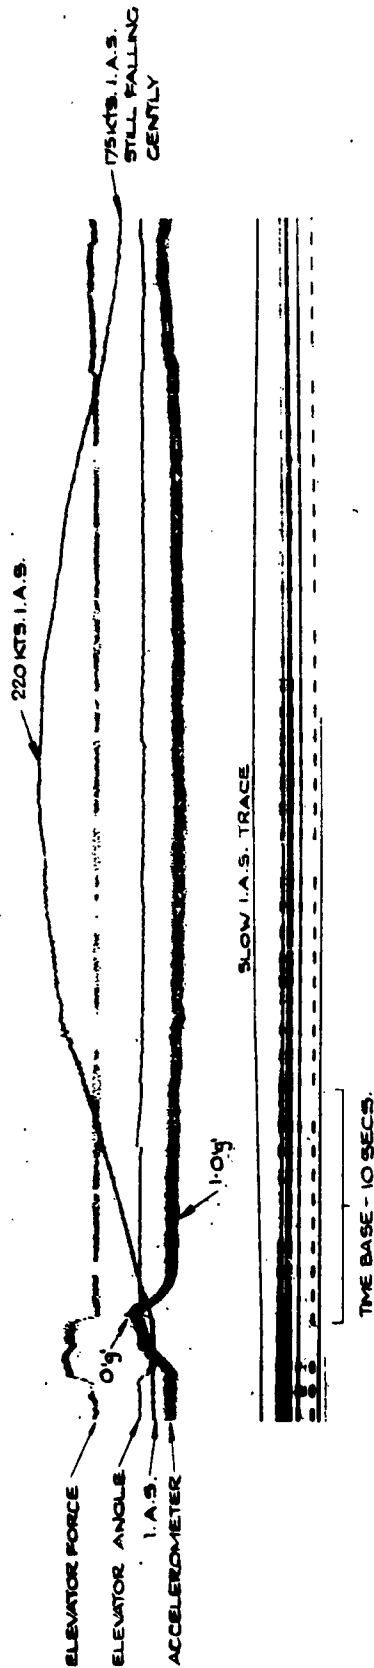
FIG.1

CLIMB AT 7800 R.P.M. c220 LB/SQ. IN. TORQUEMETER READING
 TRIMMED SPEED ON CLIMB: 165 KTS. I.A.S.
 LOADING 1 (AFT C.G. 6'-0" AFT OF DATUM. U/C DOWN 20730 LB.)

SPECIMEN HUSSENOT RECORD OF SHORT PERIOD OSCILLATION.
